DELAWARE RIVER BASIN
OWL CREEK, SCHUYLKILL COUNTY

PENNSYLVANIA
NDS ID PA. 00674
DER ID 54-2

LOWER OWL CREEK DAM

PHASE I INSPECTION REPORT
NATIONAL DAM INSPECTION PROGRAM

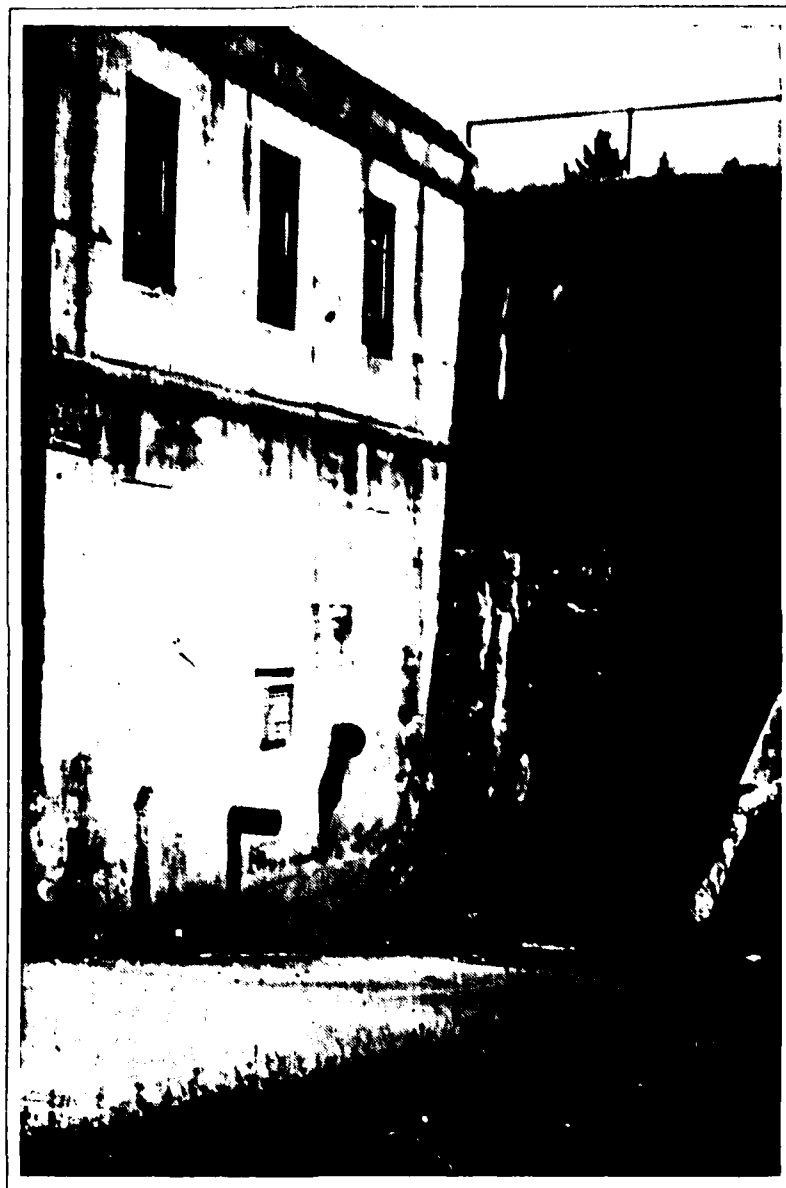
PHOTOGRAPH NO. 3

CONTROL HOUSE AND DOWNSTREAM SIDE
OF SPILLWAY STRUCTURE. NORMAL FLOW
ENTERS GRATE AND IS CONVEYED DOWNSTREAM
UNDER CHANNEL FLOOR.
